Zhone Technologies, Inc.

Field Alert Bulletin
FAB-200301
IMACS Interface Card Failure (892260, 892360 and 892460)

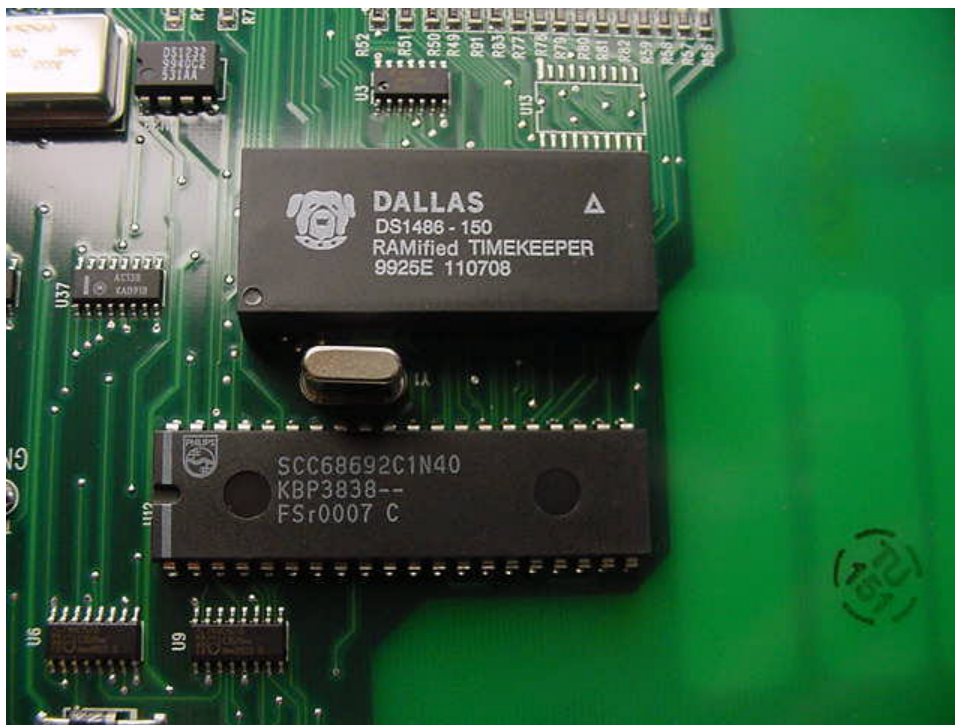
Detail of IMACS 892360 showing Philips DUART.

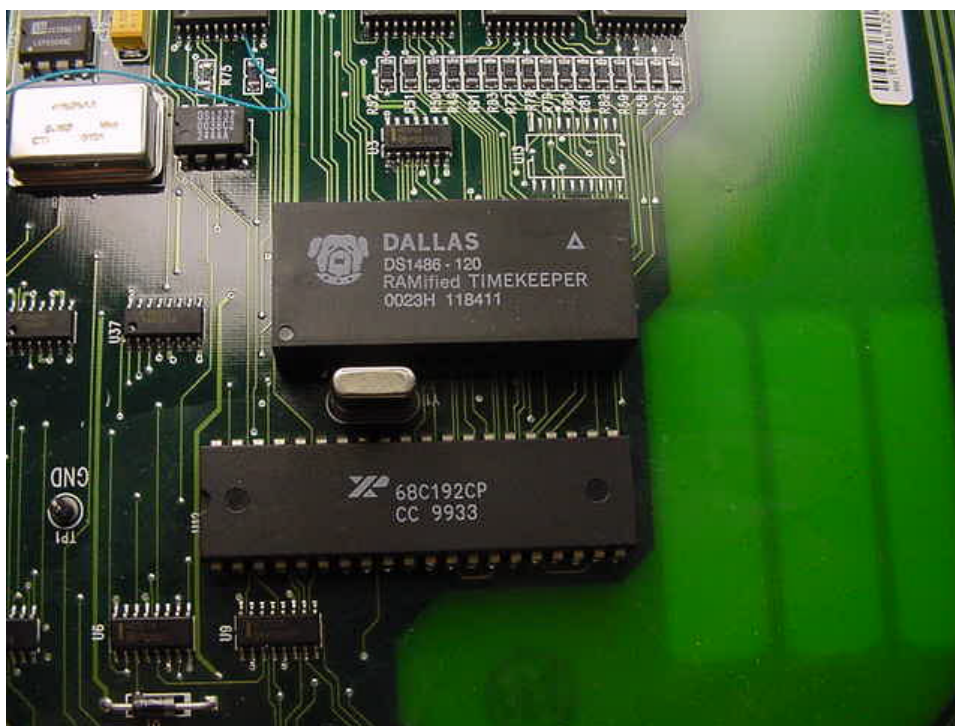
A condition exists where corrupted alarm string characters have been detected coming from the COMP port of the following IMACS interface cards:

In May 2003, corrupted alarm string characters were discovered when an IMACS system in the field was connected to a device using the newer Microsoft Windows 2000 Hyperterminal program. Zhone engineering verified the problem and corrected it by redesigning the affected circuit on the Interface cards. Due to the difference in processing timing signals, corrupted alarm string characters do not occur in the 892060 or 892160 Interface cards.

Detail of IMACS 892360 showing Exar DUART.

If you have experienced the condition where corrupted alarm string characters are being detected coming from the COMP port of the IMACS interface cards (892260, 892360 or 892460), check to see if your Interface card has the Exar DUART component (see the background information below). If it does, contact your equipment provider or Zhone Technologies, Inc., (at 1-877-946-6320, prompt #3) to have your Interface card reworked or replaced.

Rework on the Interface card consists of removing the Exar DUART and replacing it with a Philips DUART with a date code that precedes the die change made by the manufacturer, as discussed in the background information below. This will change the revision level of these Interface cards as follows:
